i-Pilot & i-Pilot Link Troubleshooting Guide

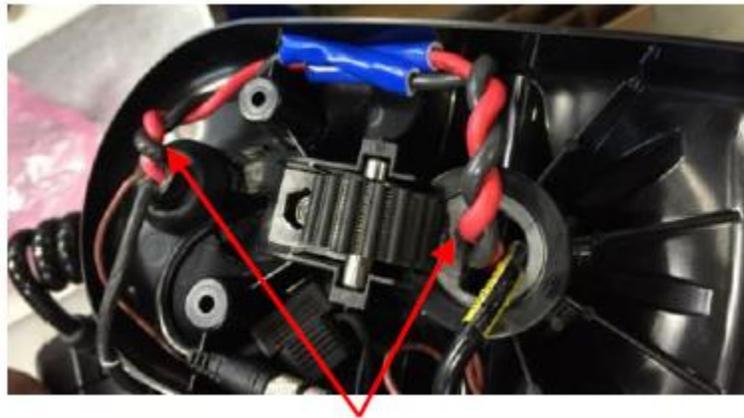
(Note that the red/black wires should be twisted three times on both the coil cord and brush lead wire sides and then the insulator or shrink tube is slid in place over the spade connectors. This picture shows an Ulterra, but the wire routing is similar and critical for all motors with i-Pilot.)

Step 4. Check to ensure proper motor lead wire routing in control box.

B-1. If the motor shaft was shortened, the brush lead wire should also be cut back the same length.

B-2. If the motor shaft was shortened and the motor has a built-in transducer, the extra transducer cable should be routed out of the control box and down the coil cord.
